**Section:** 303-01A (21)

**Model:** 2001 Mondeo 1.8L/2.0L Duratec-HE with engines built in Chihuahua (Mexico) up to 06.12.2000 inclusive

**Subject:** Engine cranks but will not start, severe loss of power, increased fuel consumption, engine knock, rough running or misfiring

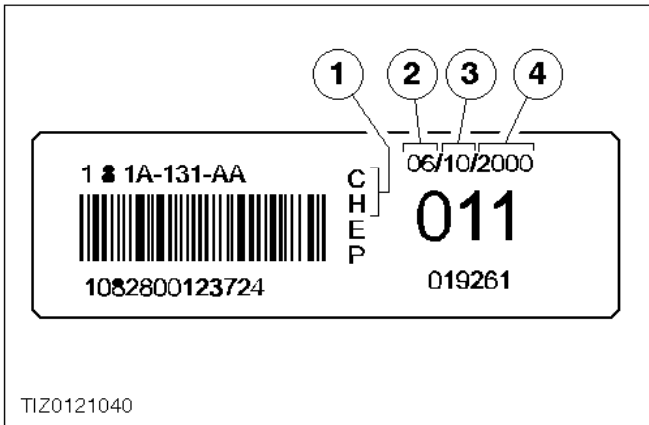
1. Check the build date of the engine on the engine identification sticker on the cylinder head cover. ONLY engines built up to 06.12.00 inclusive in Chihuahua (Mexico) are affected.
  - 1 Engine plant: CH = Chihuahua (Mexico)
  - 2 Build day of the engine
  - 3 Build month of the engine
  - 4 Build year of the engine
2. If the engine was built up to and including 06.12.00 in Chihuahua (Mexico) then go to next step. If the engine was not built in the affected build period then the position of the crankshaft vibration damper is not the cause of the concern.

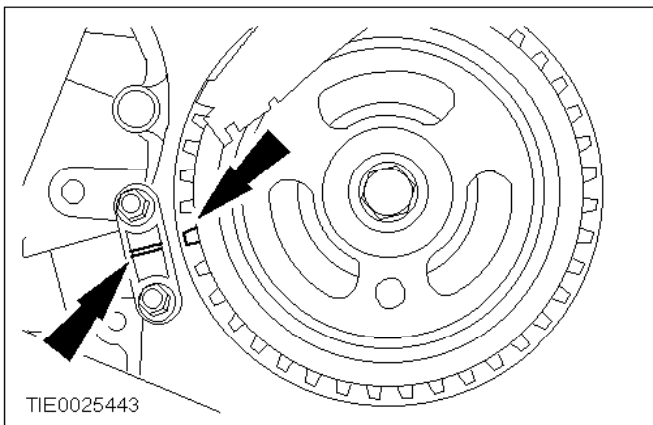
The white tooth on the sensor wheel of the crankshaft vibration damper must line up with the centre line on the crankshaft position (CKP) sensor.

8. Check the position of the crankshaft vibration damper.
  - If the markings line up, the position of the crankshaft vibration damper is not the cause of the concern.
  - If the markings do not line up, go to next step.

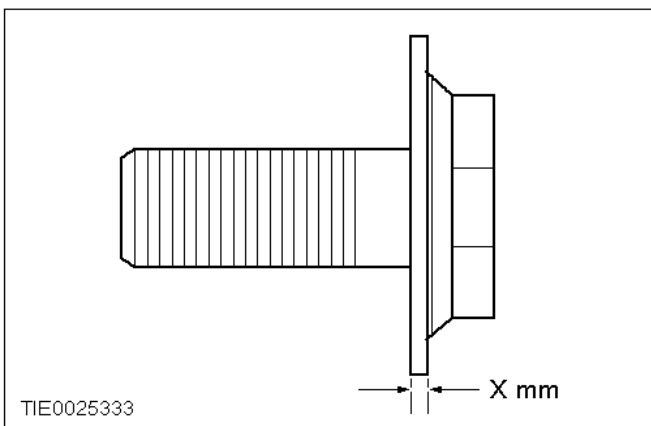
- 25. Measure the thickness of the vibration damper bolt washer.
  - If the thickness is less than 5.5 mm, discard the friction washer. Go to next step.

- If the thickness is greater than 5.5 mm then a new friction washer has already been installed. Reinstall the existing washer and go to step 27.
