**Section:** 303-01A (21)

**Model:** 2001 Mondeo 1.8L/2.0L Duratec-HE with engines built in Chihuahua (Mexico) up to 06.12.2000 inclusive

**Subject:** Engine cranks but will not start, severe loss of power, increased fuel consumption, engine knock, rough running or misfiring

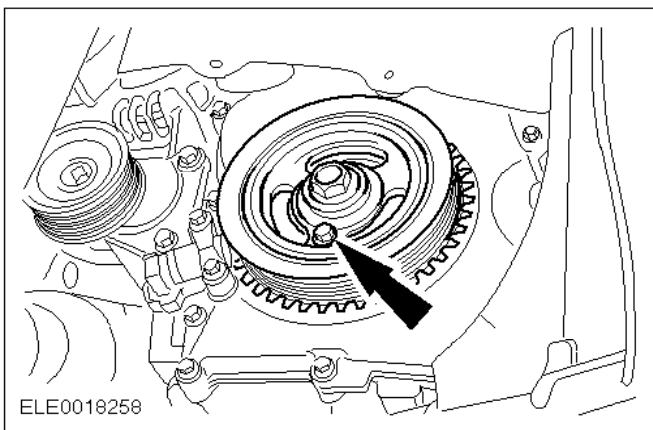
**Note:**

Maximum bolt length: 18 mm.

Tighten the bolt finger tight.

- ⑥ 27. Position the crankshaft vibration damper and locate using a M6 x 18 bolt.
